245 Lynnfield Street  
Peabody, MA 01960-5099, USA  
Tel. 978.532.0775  
Fax 978.531.6993  
[www.trucorporation.com](http://www.trucorporation.com)

## 1-5/8 EIA Mating Durability Test Report

Test & characterize the mating durability of a TRU manufactured 1-5/8 EIA interface using phosphor bronze contact over an extended number of mating cycles to simulate a lifetime of performance. The test will measure and monitor the following parameters: VSWR, insertion loss, flare diameter of contact, to determine their impact on electrical/ mechanical performance.

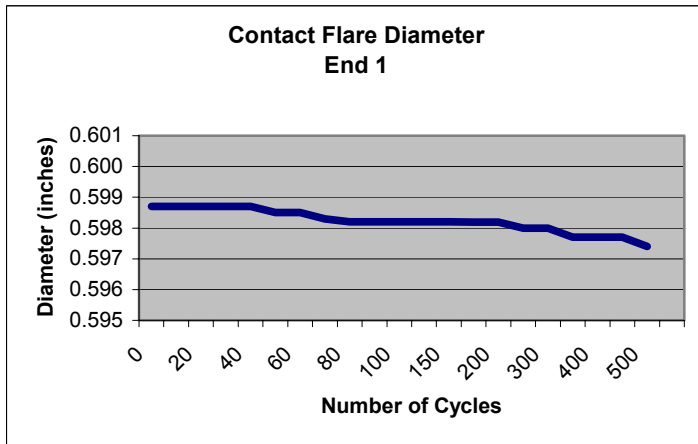
*Figure 4*

**Contact Flare diameter measurements**

- TRU 1-5/8 EIA meet /exceed 500 mating cycles, without any significant degradation to electrical / mechanical performance parameters. The test results were summarized and recorded per the following data: See figures 4-8.
- The VSWR and contact flare diameter following the extended mate test revealed little to no change.
- There was significant plating wear on the contact (see figures 9-11), but this did not affect electrical performance. The first signs of plating wear noticed after 60 cycles.
