# Fiber Optic Video Jacks for Outdoor Sporting Venue

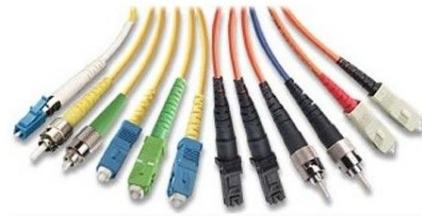
Standard Physical Contact Fiber Optic Connectors

Conventional Fiber Optic connectors are designed so the fiber center cores butt together, known as 'butt joint' or physical contact connectors. It is critical that the two fiber cores maintain contact and alignment when mated to minimize signal loss.

To maintain contact, all PC connectors have a spring pushing the fibers together. As the fiber connectors are mated, the ferrules holding the glass fibers touch, compressing and allowing the glass to touch with a force of a few pounds. The core of the fiber is around 9 microns (.009 mm or .0004 in.). Typical dust particles in the air of a normal office environment are 2 to 30 microns, so there is a very real and ever-present risk that when a connector is unmated and then remated, a dust particle will settle on the glass.

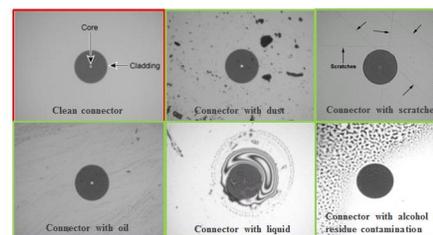
Types of Contamination

Dust particles getting on the glass can do two things, worst-case it will block all the light and no signal will pass through, or it will sit on the glass and not block the light, but it will scratch or pit both connector surfaces. If that chipped, scratched, or dirty connector mates with another connector, it can transfer the dust, scratch the connector, or move any existing dust into a place that will block the light. 'Dirty' connectors refer to a speck of dust that is invisible to the naked eye, and generally impossible to remove without special cleaning tools or fluids. Wiping the connector on a piece of cloth will likely scratch it. It is a random occurrence, so it may be possible to do 10 or even 100 matings without seeing a performance drop due to dust, but it is certain that after a number of matings without proper cleaning, the optical performance will drop or the signal will disappear altogether. Further complicating matters, unmating and remating may bring the signal back, or may permanently damage the fiber.

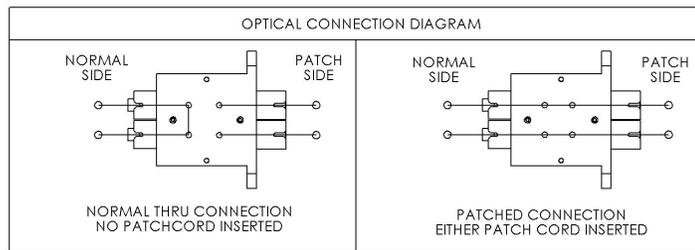
Our engineers designed and patented EL Series Fiber Optic Video Jack. Due to the increased reliability and performance achieved, this groundbreaking device was recognized by the IABM as the most innovative broadcast product, and TV Technology recognized it with its STAR award for Superior Technology.

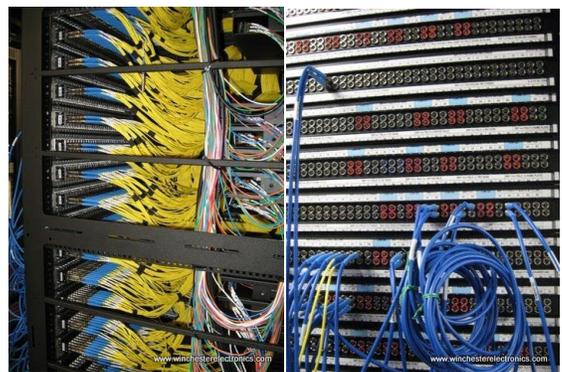
EL Video Jack Installation in Florida Sporting Venue

Implementing the EL Series Fiber Optic Video Jack allowed the customer to ensure the correct input could be connected to the correct output by using the patch cable. By doing so they were able to guarantee a good signal every time.

When faults occurred, they were easily able to diagnose and remedy the issue so that signal would resume. The elimination of connection problems in the studio combined with the reduction in fault finding time for field issues saved the customer many hours of maintenance and offered a rapid return on investment. Since the initial installation, no video jack has failed and no patch cord has ever required cleaning.
