TRU BMA Products Test Report

Objective

Verify the durability of TRU BMA connector products over extended cycling of mating and unmating. The process is meant to simulate the lifetime mating of the connectors and to measure the effects on the electrical and mechanical performance. Parameters measured were VSWR, insertion loss, RF leakage, insertion force, and extraction force.

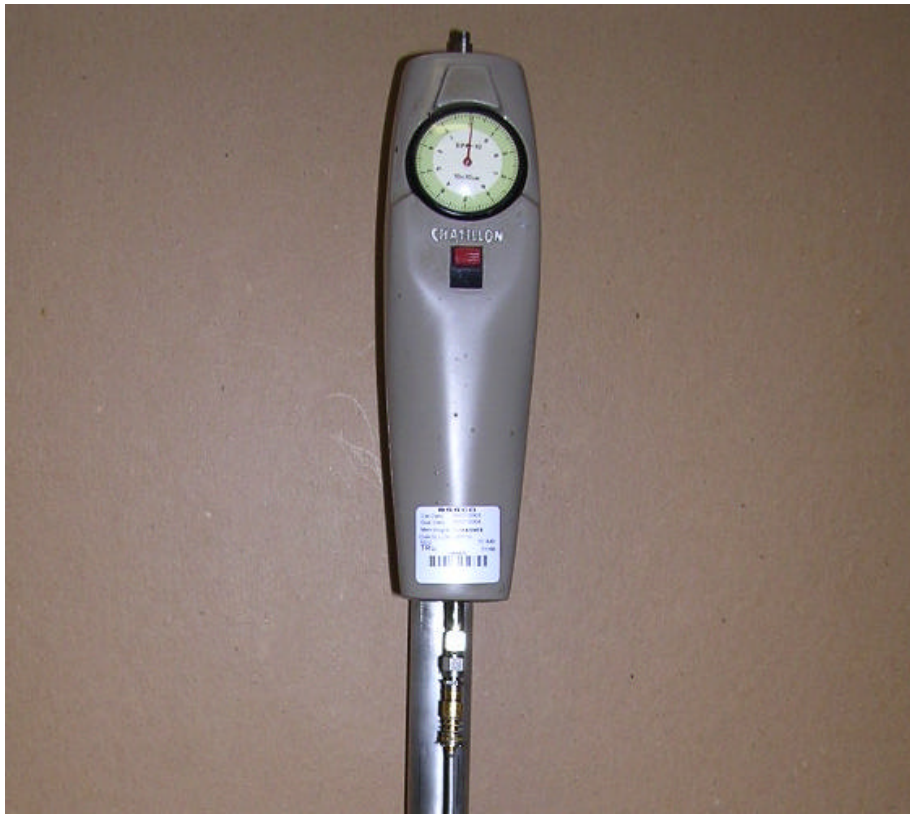
Figure 3, Mechanical Test Setup

Insertion force and extraction force measurements were taken using the configuration shown in figure 3. Refer to Table 1 for the results of the baseline testing.
